Residual Contamination and Environmental Effects at the Former Vanda Station, Wright Valley, Antarctica.

**Submitted in partial fulfilment for the degree of
Master of Water Resource Management
Waterways Centre for Freshwater Management, University of
Canterbury, New Zealand
2015**

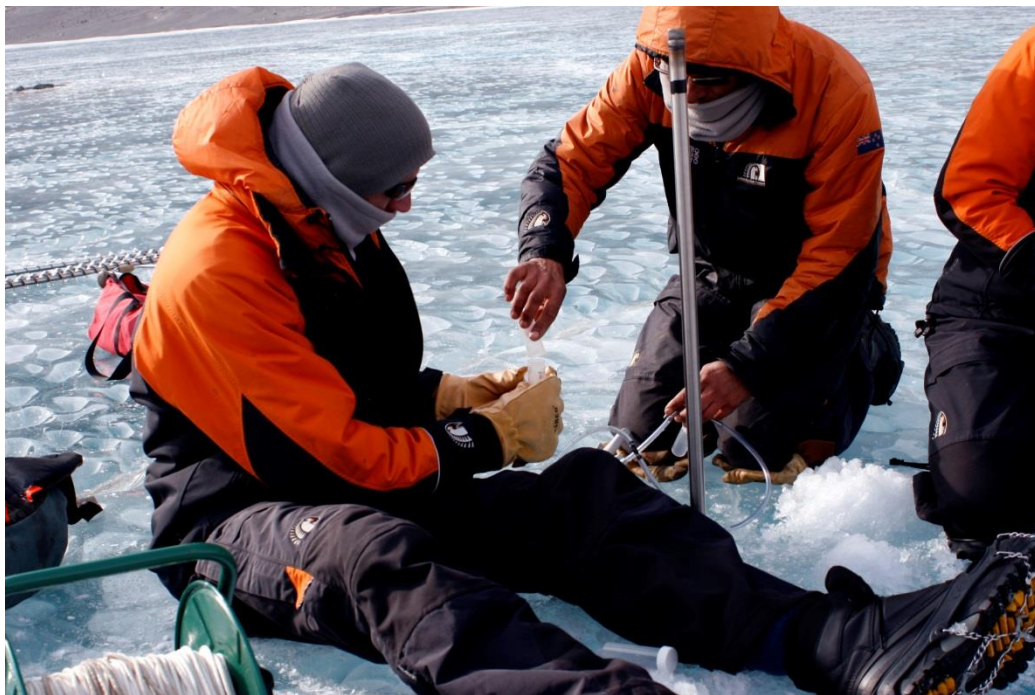
Figure 13 - Sample collection and field measurements. Samples were drawn through water sampler via suction pump and sub sampled.

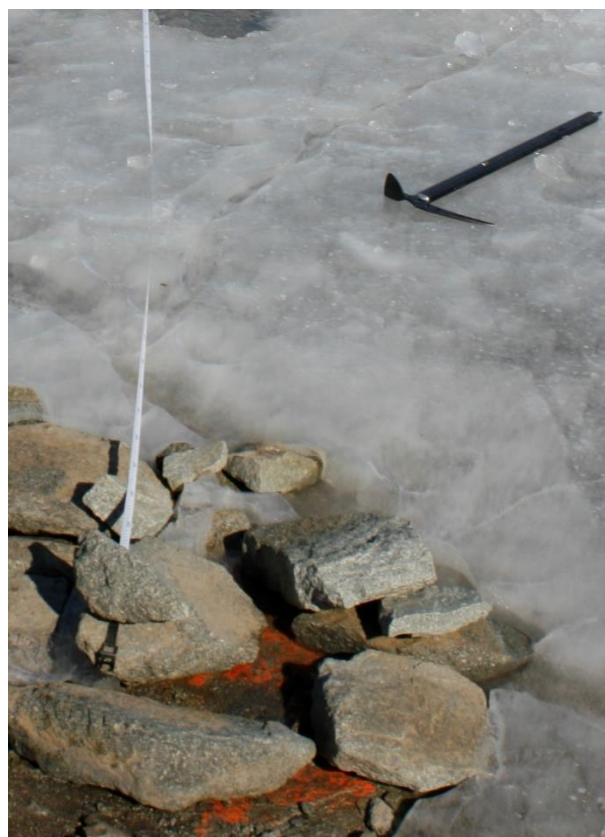
Figure 18 - Orange painted rock at the edge of Lake Vanda in the vicinity of HP21.

The former main helicopter pads were located to the west of the former station (Figure 10, Figure 11); and were marked out using orange painted rocks. While these rocks now form the boundary for the new helicopter pad at the Vanda Huts, some painted rocks remain in position at the former pads (Figure 18). The helicopter pads have been recently inundated by Lake Vanda and lie at a depth of 15cm (Figure 17). There was no observable sign of contamination in the water around HP21, HP22, and HP23 except for the painted marker rocks and litter. Cyanobacterial mats were observed in the vicinity of the helicopter pads (Figure 30). The helicopter pad site HP5 lay further into Lake Vanda. The depth of water prohibited observation of any signs of contamination.

Litter and debris was observed and some was collected from the former station island and the helicopter pads for removal and disposal at Scott Base. This debris included batteries (Figure 32), wood chips, nail and screws, pain flecks, and painted stones. A total of 500g of debris was removed, noting that we were not actively searching for debris and simply collected obvious items close to sampling sites. The former helicopter pad and the survey marker “Astro - A” are marked with orange painted rocks. These rocks lie close to lake level will soon be submerged (Figure 18). Additionally, approximately 20 orange painted rocks lie at the current helicopter pad adjacent to the Vanda Huts.

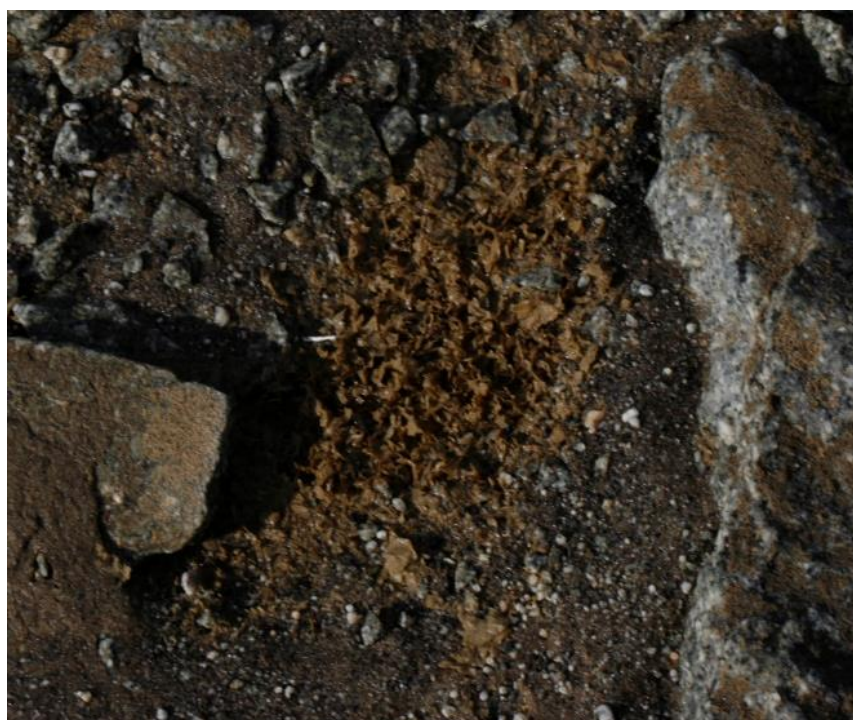
Figure 30 - Cyanobacterial mat growing on sediment on the edge of HP21, photographed area approximately 30cm x 30cm .

Cyanobacterial mats were observed at 5 sites; one instance on recently inundated soil (Figure 30) and four from sites under approximately 3m water (Figure 31). The four sites under water were GW0, GW4, GW5, and VBG.

There was strong growth of cyanobacterial mats in all of the sites photographed, with greater growth observed in sites GW4 and GW5. There were no obvious signs of inhibited growth (Figure 31). Site GW5 (Figure 31c) showed signs of mat 'lift-off'. This is common in healthy cyanobacterial mats under ice in shallow water and is caused by entrapment of gas in the mat causing increased buoyancy (Hawes & Schwarz, 1999).

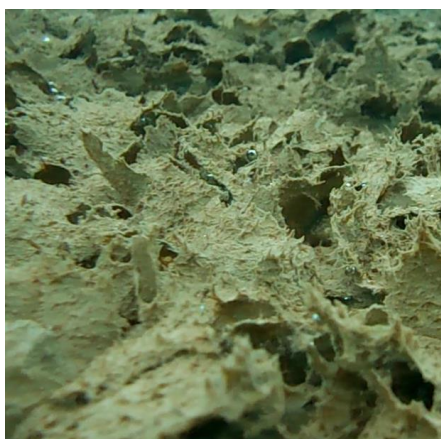
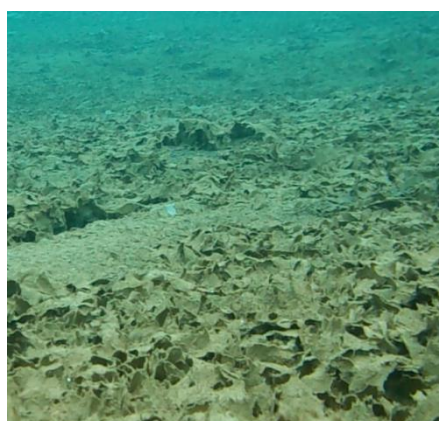
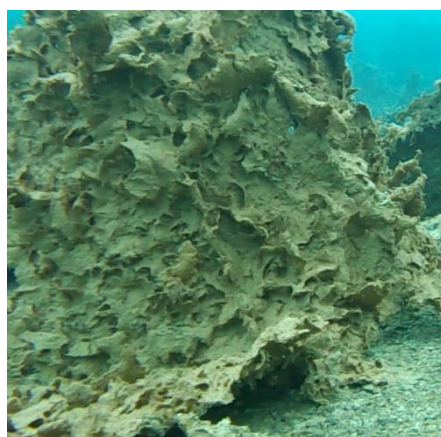
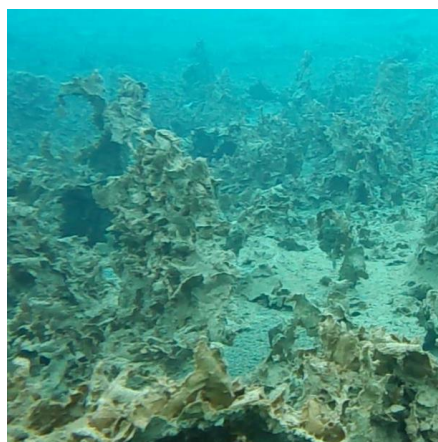
Figure 31 - Underwater camera observations of cyanobacterial mat growth at GW0 (a), GW4 (b), GW5 (c) and VBG (d).

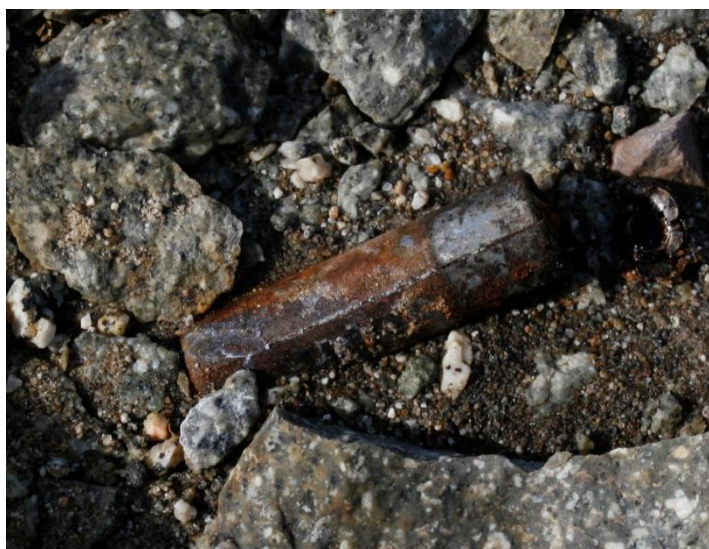
Figure 32 - Battery found in the soil near site HP23.

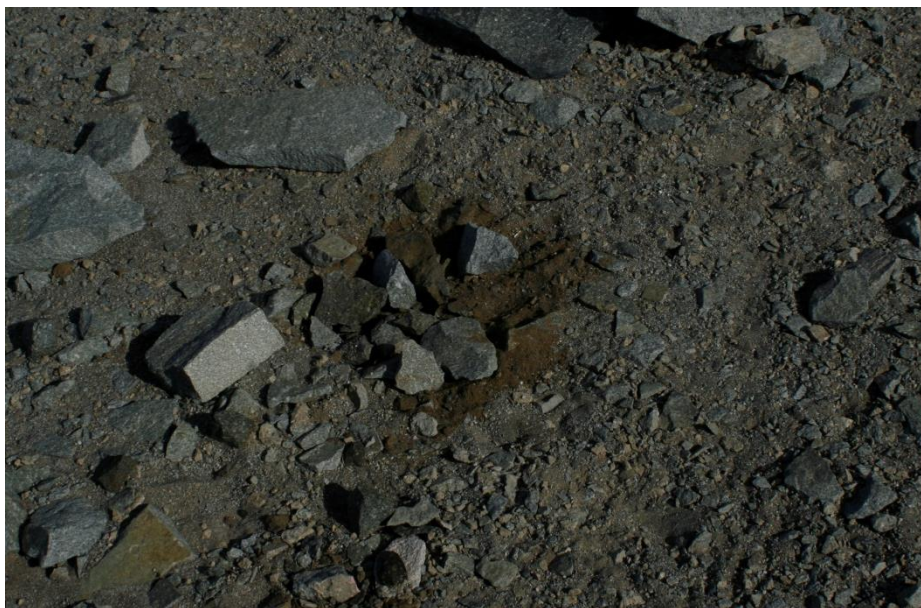
Figure 33 - Discolouration of the soil at site HP20. This site smelled strongly of hydrocarbons.
